DOT/FAA/AR-96/48

Fuel Fire Penetration Test and Destruction of a Transport Aircraft

December 1996

Final Report

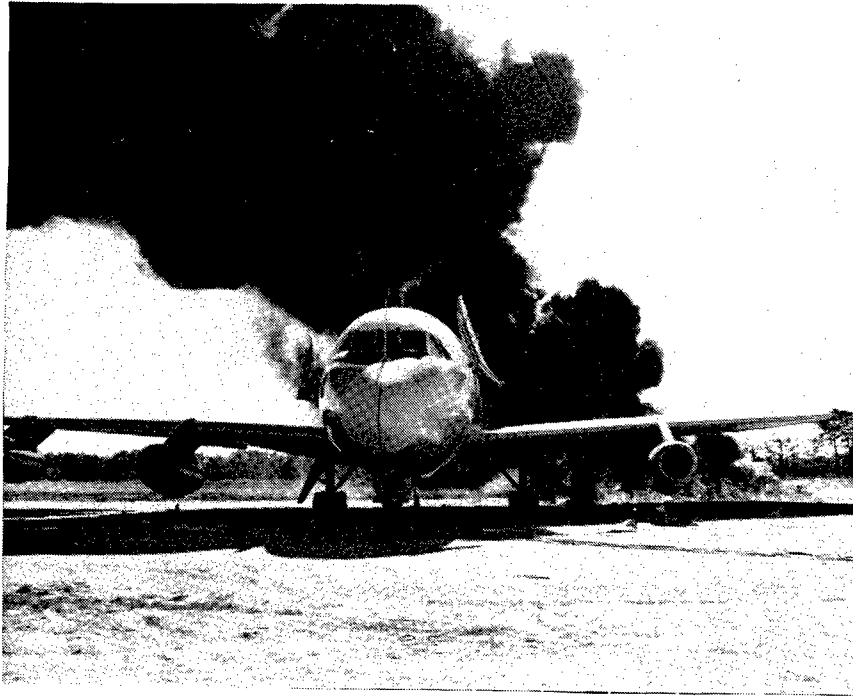
FIGURE 4. FULLY DEVELOPED FUEL FIRE, FORWARD VIEW, 20 SECONDS AFTER IGNITION

The external fuel fire burned steadily for 8 minutes and did not self-extinguish from lack of fuel until 11 minutes 15 seconds had elapsed. The fire plume was blown by the 12-knot wind against and over the rear fuselage (figures 4 and 5). However, long before the pool fire was out, the interior of the aircraft supported a self-sustaining cabin fire. Two minutes twenty-five seconds after the pool ignition a visible seat fire was observed in the main cabin. Two minutes thirty seconds into the test, heavy black smoke was observed pouring from the starboard rear service door. A small fireball erupted from the starboard rear service door at 2 minutes 47 seconds.

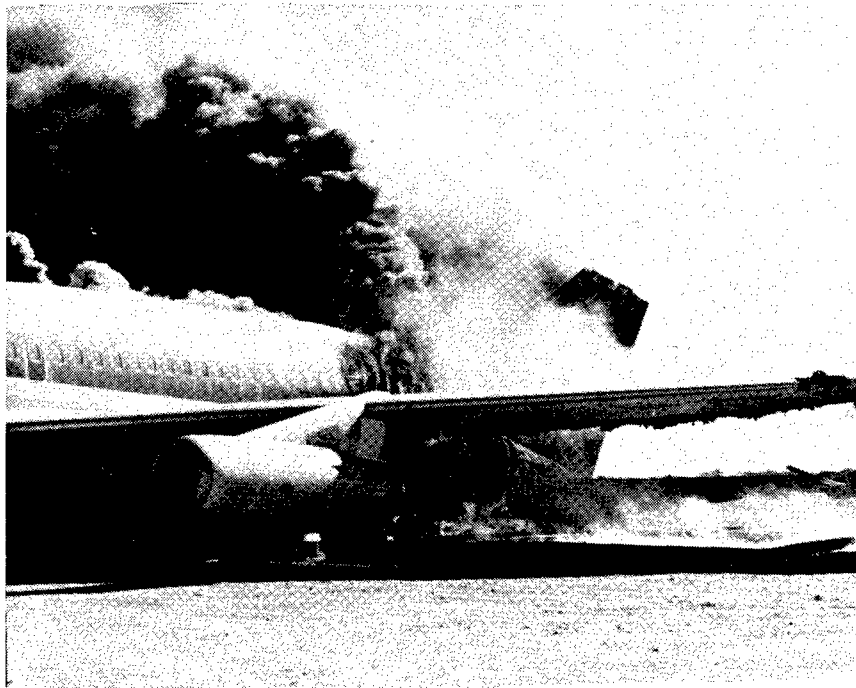
FIGURE 8. INTERNAL FIRE PROGRESSES FORWARD TO STATION 933,
10 MINUTES AFTER IGNITION

The port side windows burned through from the inside at stations 973 and 1011 at the 10-minute mark (figure 8).

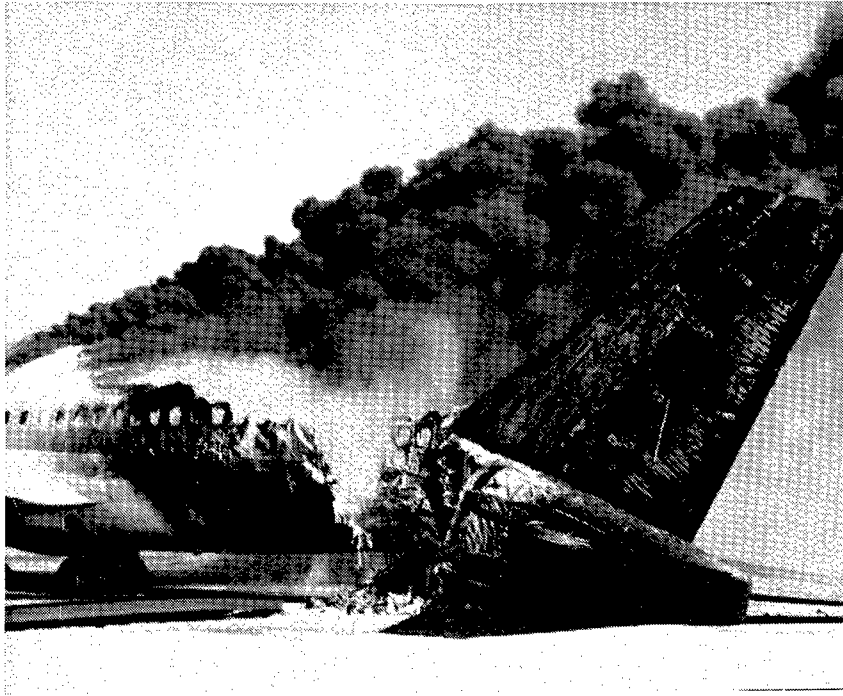
FIGURE 9. THE TOP OF THE FUSELAGE IS BURNED THROUGH FROM STATION 749 AFT, 20 MINUTES 12 SECONDS AFTER IGNITION

The top of the fuselage began to turn brown at stations 749 and 603, and by 20 minutes 12 seconds, the entire top of the fuselage from station 749 aft is burned through (figure 9). Flames penetrated the top of the fuselage at station 508 at 21 minutes 45 seconds. The entire top of the fuselage from station 479 aft was consumed by the fire at 23 minutes 20 seconds. By 24 minutes 50 seconds, this had progressed to station 342 (figure 10). At 27 minutes 55 seconds, all combustibles aft of station 758 were consumed, the fuselage was burned down to the window level, and the fire continued to burn in the first-class cabin. By 29 minutes 30 seconds, the fire in the first-class cabin and the cockpit began to die down as all remaining combustibles were consumed.

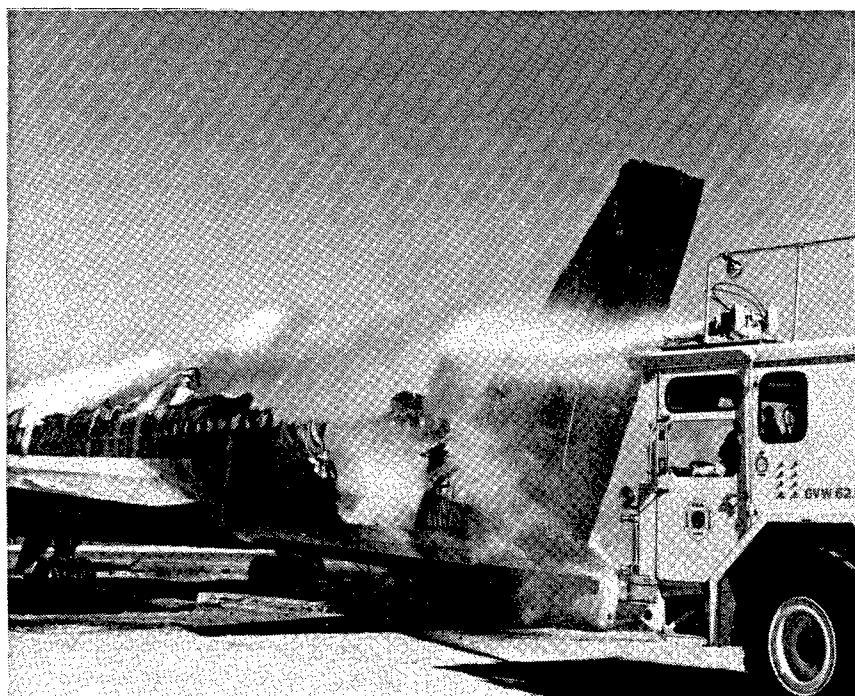
FIGURE 11. REMAINING FIRE IS EXTINGUISHED BY AIRPORT FIRE SERVICE, 33 MINUTES AFTER IGNITION

At 33 minutes, the remaining smoldering fire was extinguished by the Airport Fire Service (figure 11).

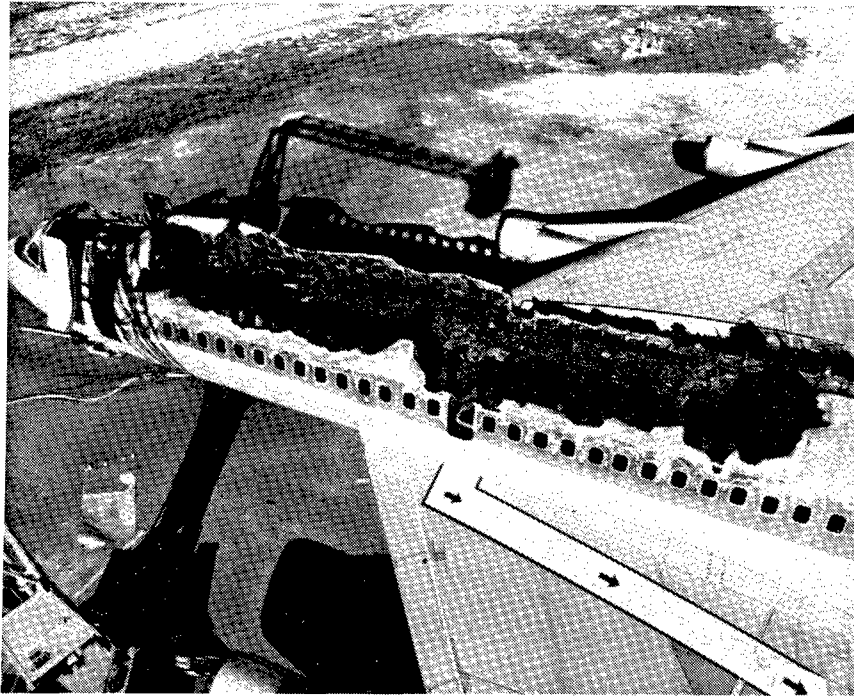
FIGURE 12. AERIAL VIEW OF CABIN FORWARD AFTER FIRE

The entire interior of the aircraft was completely gutted. There were no recognizable interior furnishings. All of the windows, with the exception of those on the flight deck, were consumed. The top of the fuselage was burned down to just above the windows (figures 12 and 13). The entire empennage assembly was separated from the fuselage at station 1264 (figure 14). The cabin floor was consumed aft of the main wing spar. Forward of the main wing spar, the floor was intact as well as the forward cargo compartment. The remaining floor support beams were weakened, twisted, and sagging.

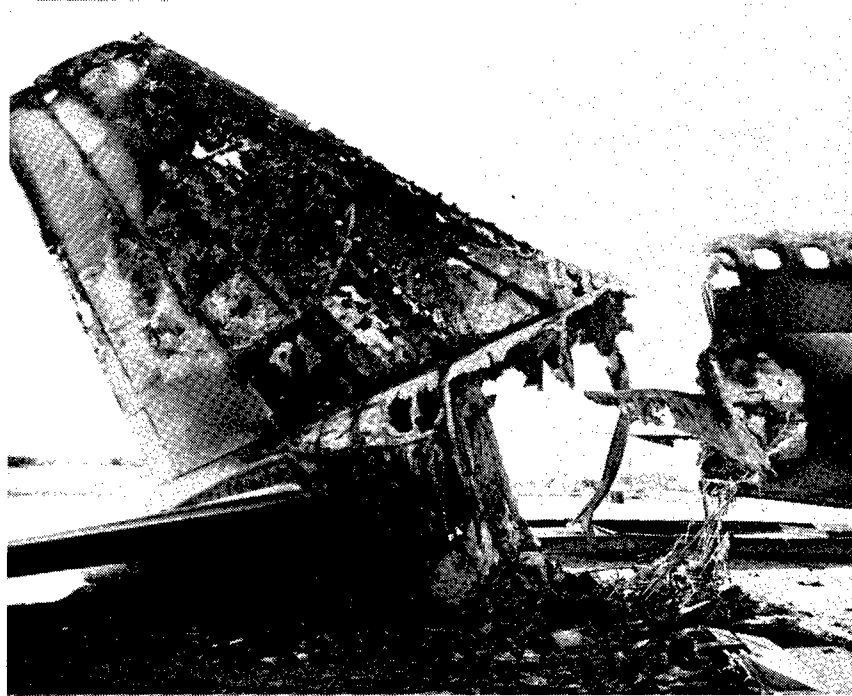
FIGURE 16. STARBOARD SIDE OF VERTICAL STABILIZER HEAVILY COATED WITH SOOT

The skin on both sides of the leading edge of the vertical stabilizer and the port horizontal stabilizer was perforated. The starboard side of the vertical stabilizer was heavily coated with soot (figure 16). The starboard horizontal stabilizer was soot coated but relatively undamaged. The tail cone was lightly soot coated but undamaged to the naked eye.

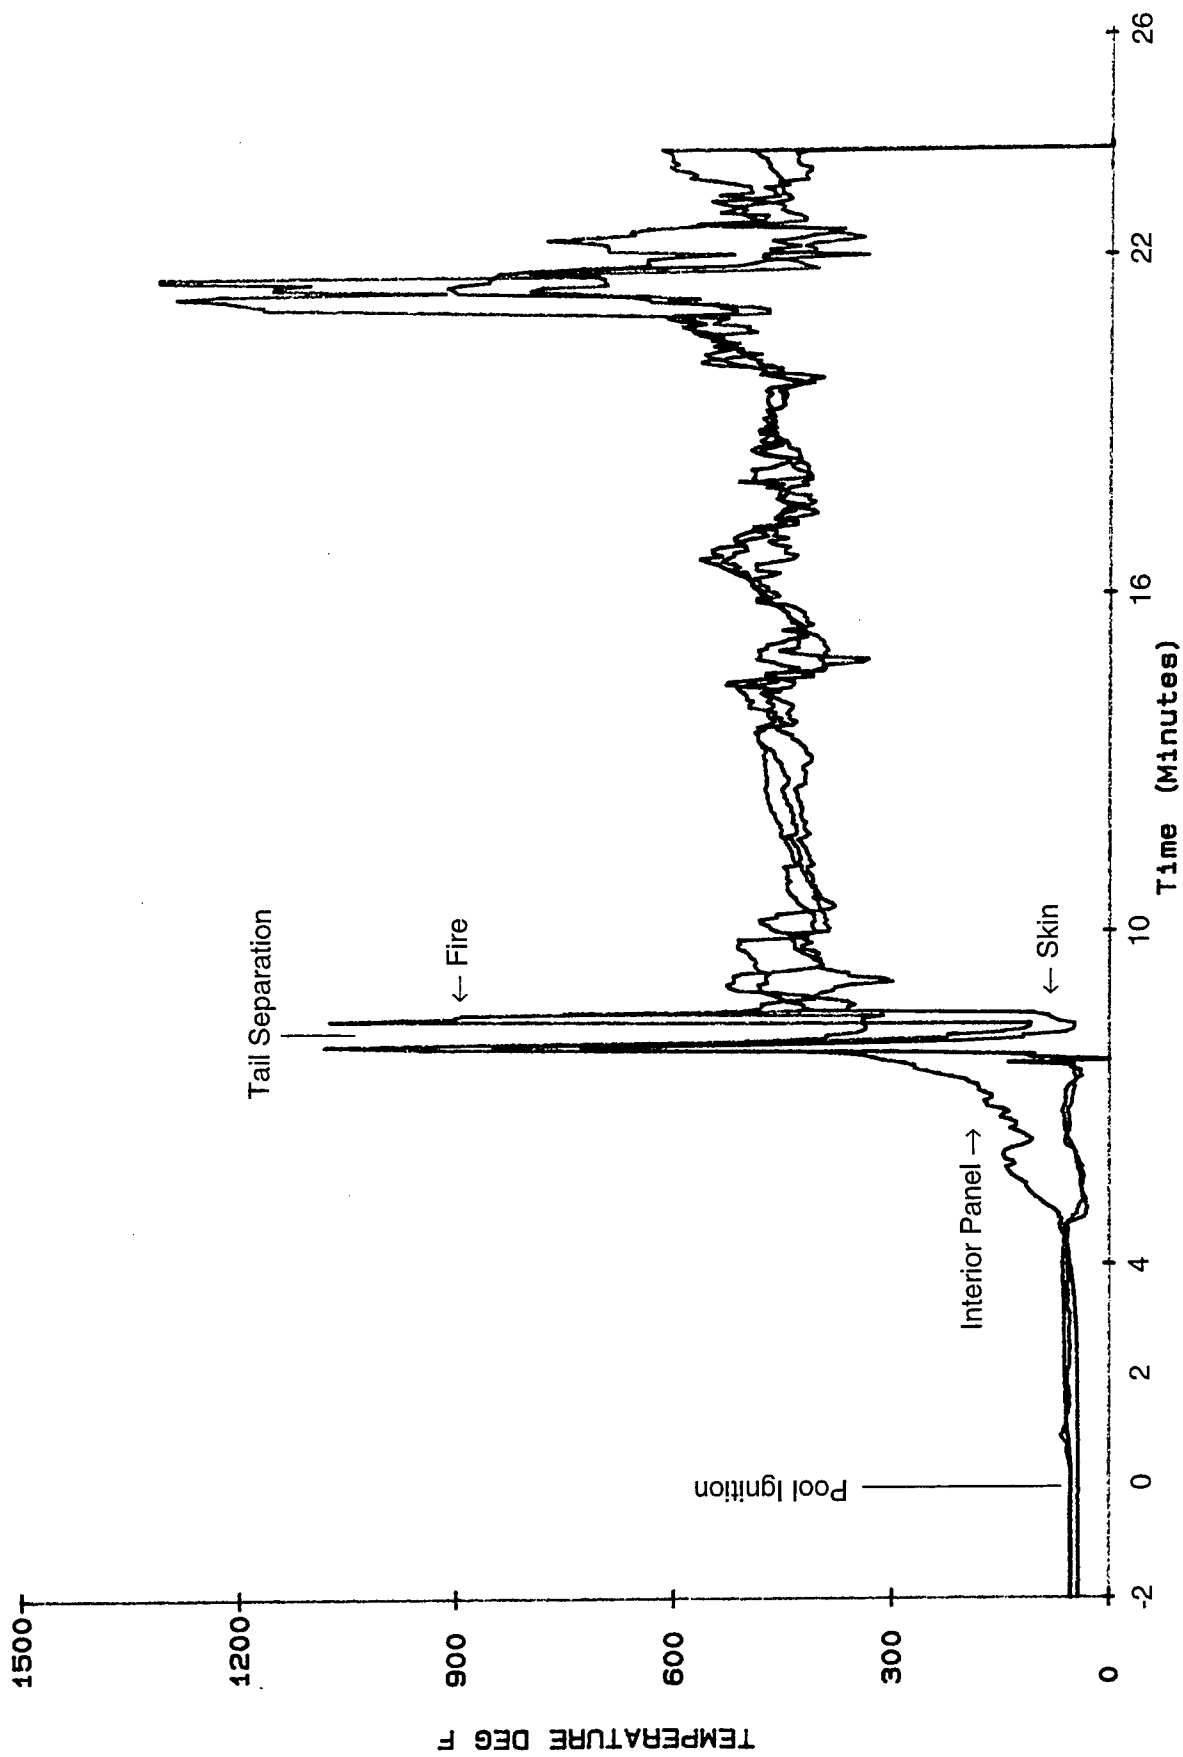
FIGURE B-5. TEMPERATURE PROFILE THROUGH FUSELAGE SKIN AT STATION 1192, BELOW WINDOW, STARBOARD SIDE

Figure B-5 is the temperature profile through the hull just below the window on the starboard side. The area was not exposed to the exterior pool fire. The temperature of the interior sidewall panel began to rise at 5 minutes. This is an indication of the interior cabin fire and not burnthrough as can be seen by the lower skin temperature.

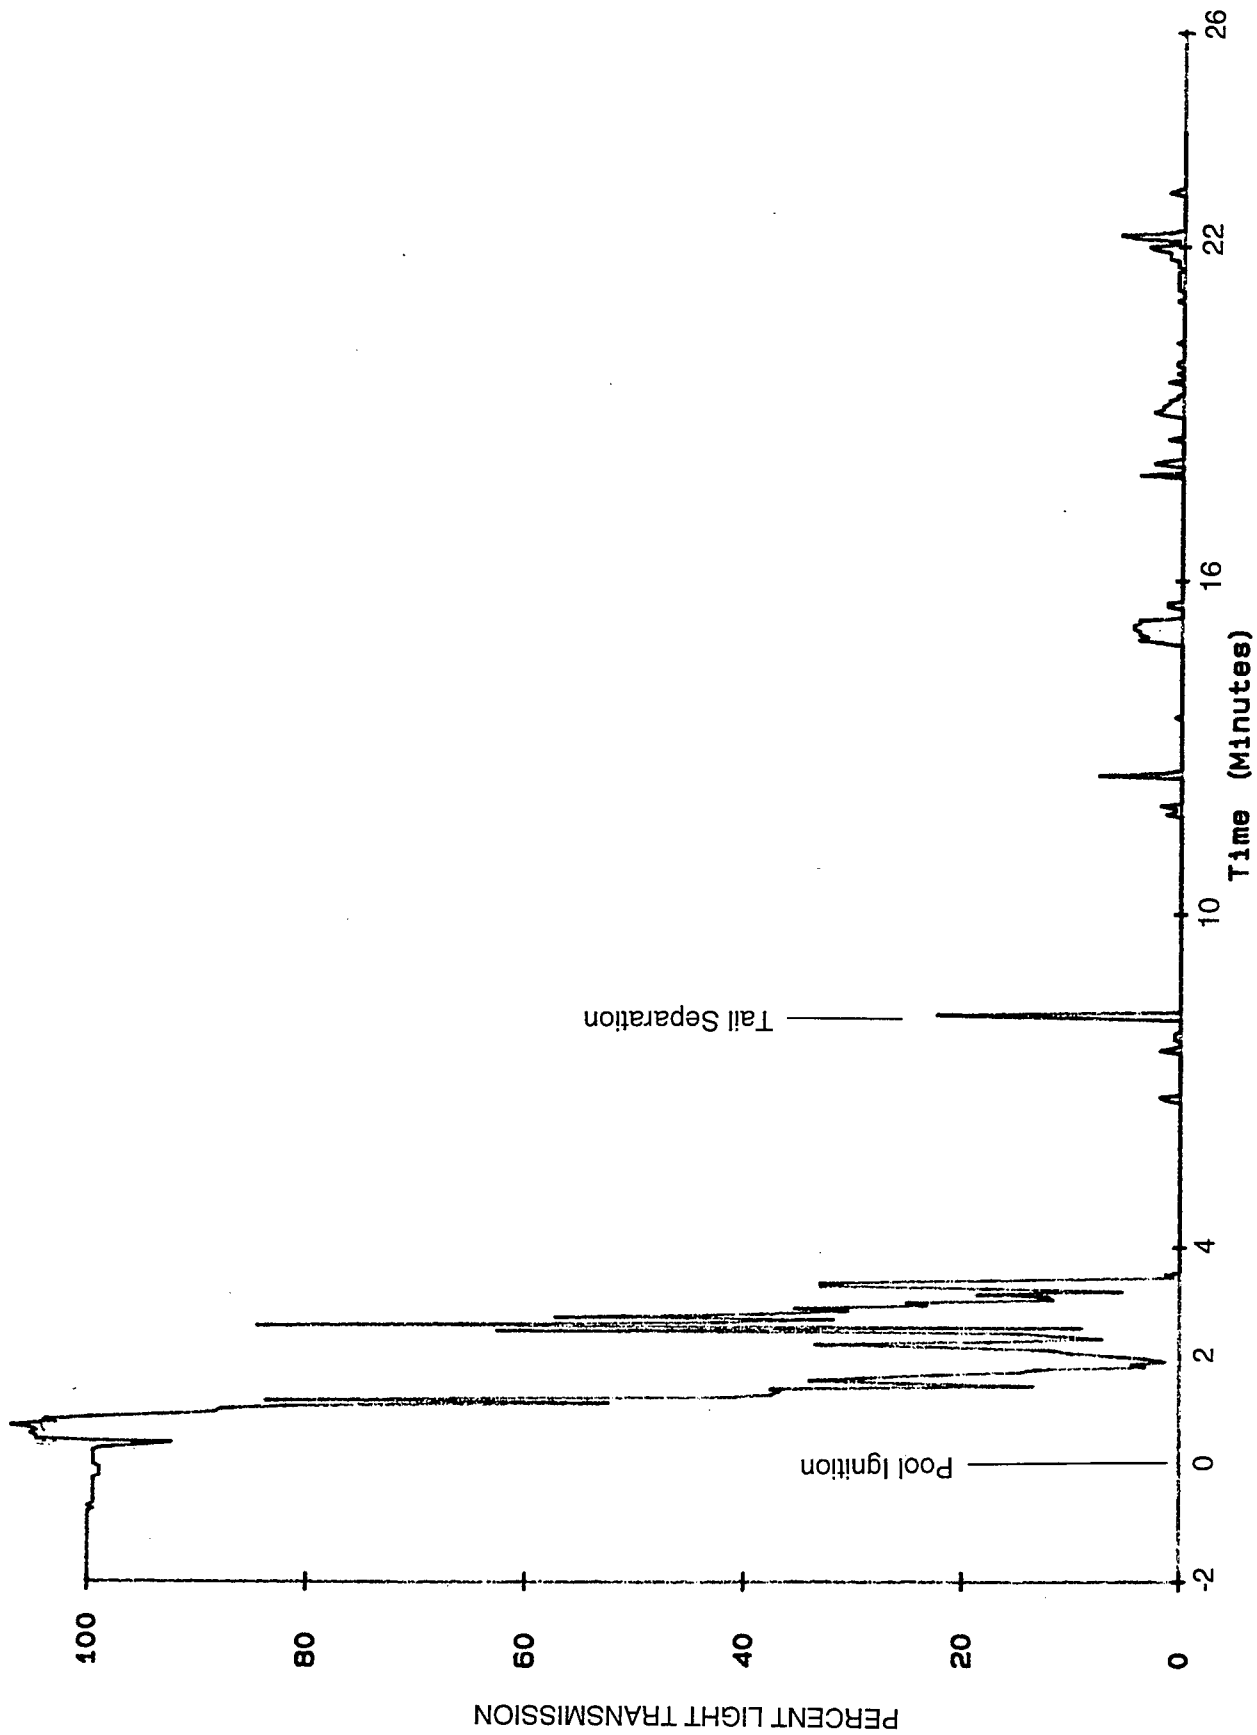
FIGURE B-12. SMOKE DENSITY AT STATION 1280

Figures B-12, B-13, B-14, and B-15 are percent light transmission measurements obtained 48 inches above the floor. The smoke meter for figure B-12 was located in the rear of the aircraft at station 1280. This figure shows a steep drop in light transmissibility beginning 1 1/2 minutes after the pool fire was ignited or only 19 seconds after the first flame penetration was observed in the main cabin at station 1220.

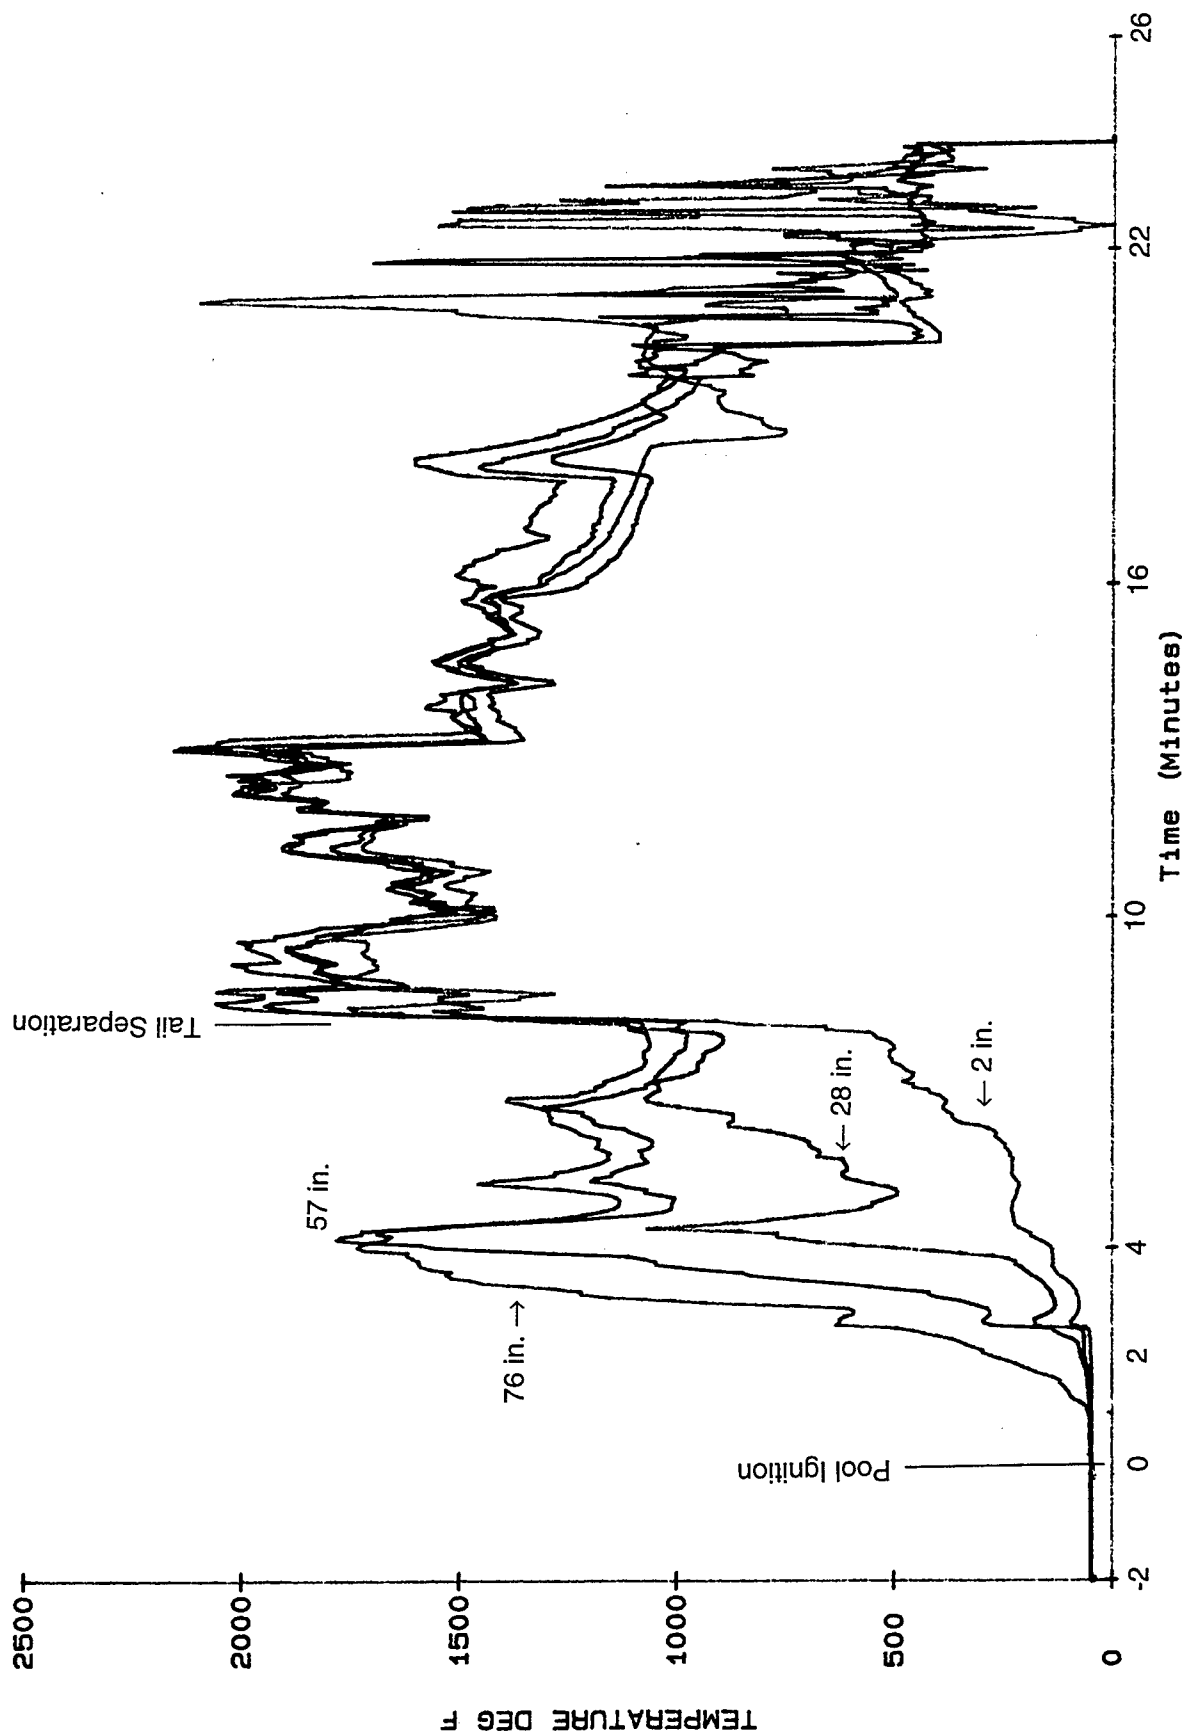
FIGURE B-16. THERMOCOUPLE TREE 1 AT STATION 1280

Figure B-16 shows a vertical air temperature profile at station 1280 across from the starboard rear service door. The ceiling temperature began to rise a few seconds after the burnthrough at station 1220, approximately 1 minute 20 seconds after the pool was ignited. The ceiling temperature indication peaked at 1750°F at about 4 minutes and then dropped off to 1200°F. The temperature peaked again at 2000°F when the tail separated from the aircraft.

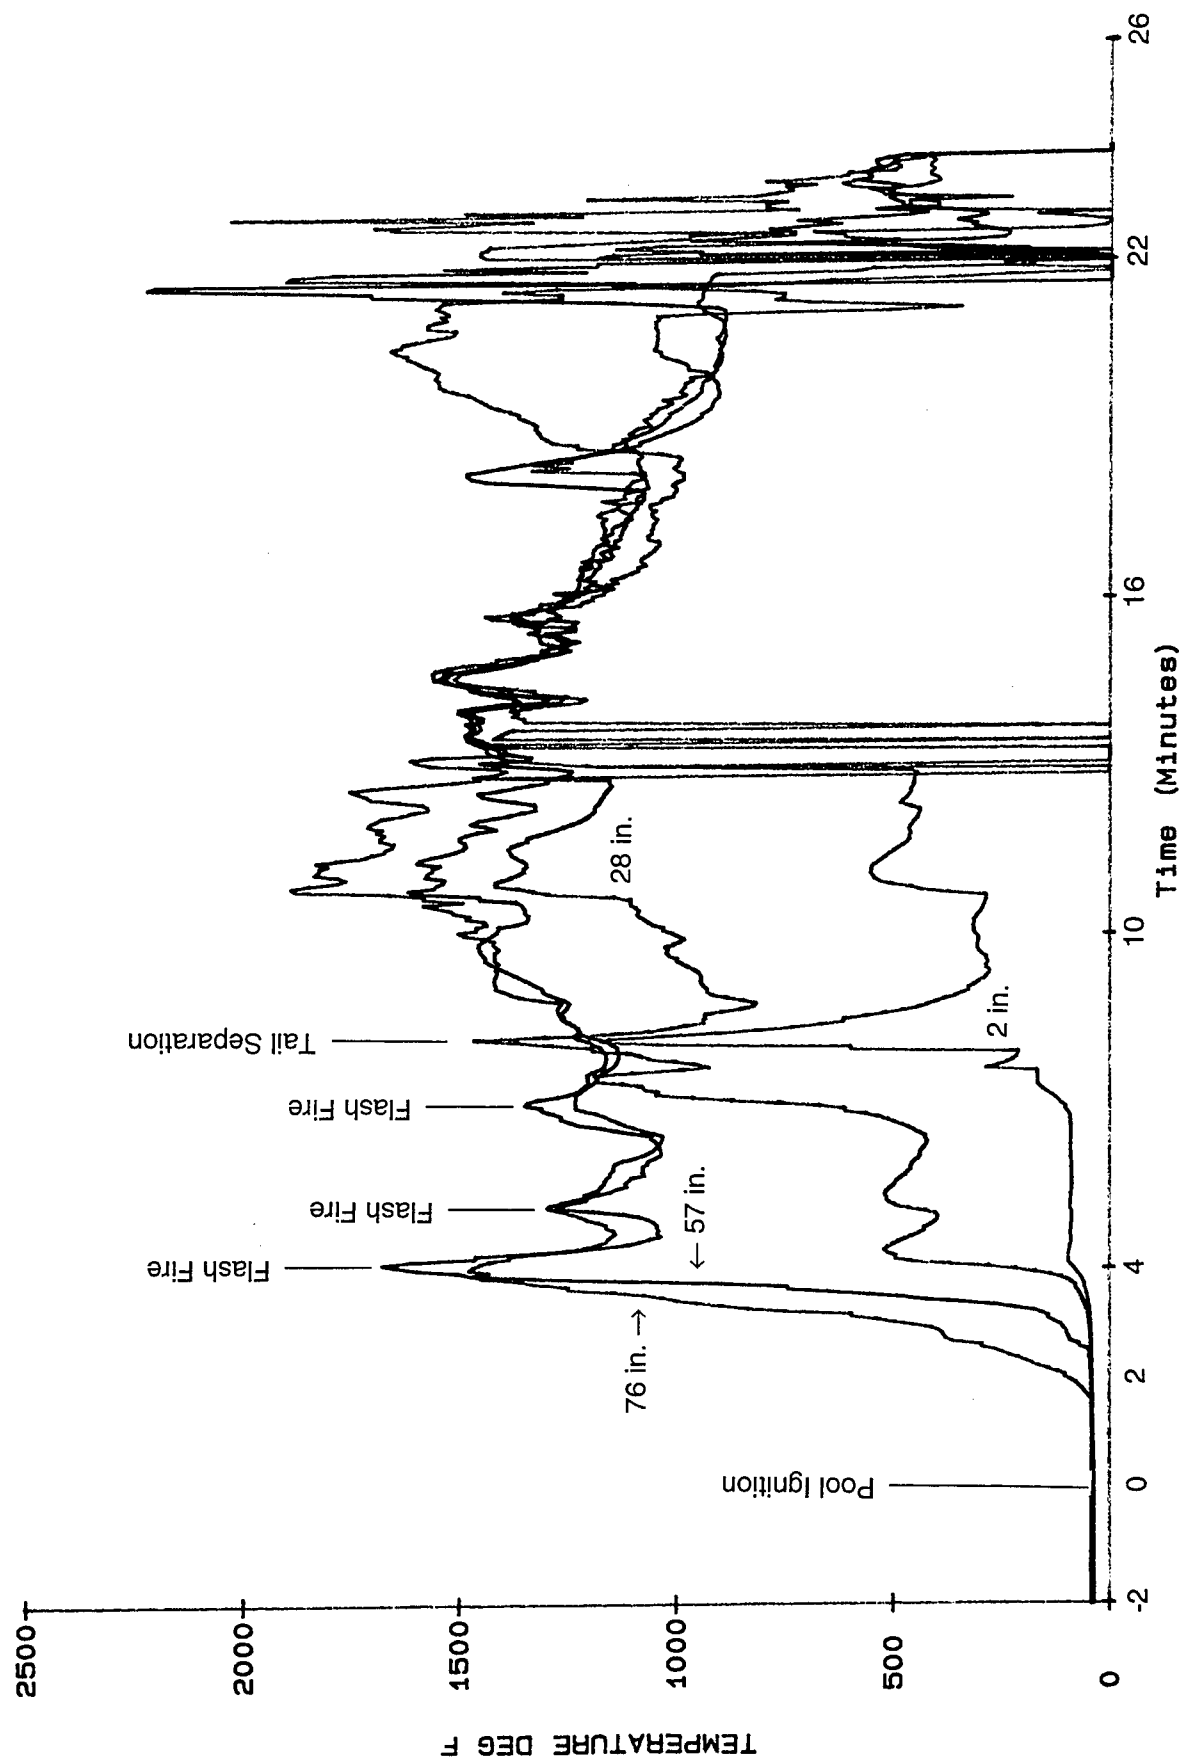
FIGURE B-17. THERMOCOUPLE TREE 2 AT STATION 1106

The thermocouple tree at station 1106 was located 10 feet forward of the initial burnthrough at station 1220 (figure B-17). The ceiling temperature began a rapid rise 2 minutes after the pool fire was ignited or just 50 seconds after the burnthrough. The ceiling temperature peaked at 1700°F at 4 minutes after pool ignition.

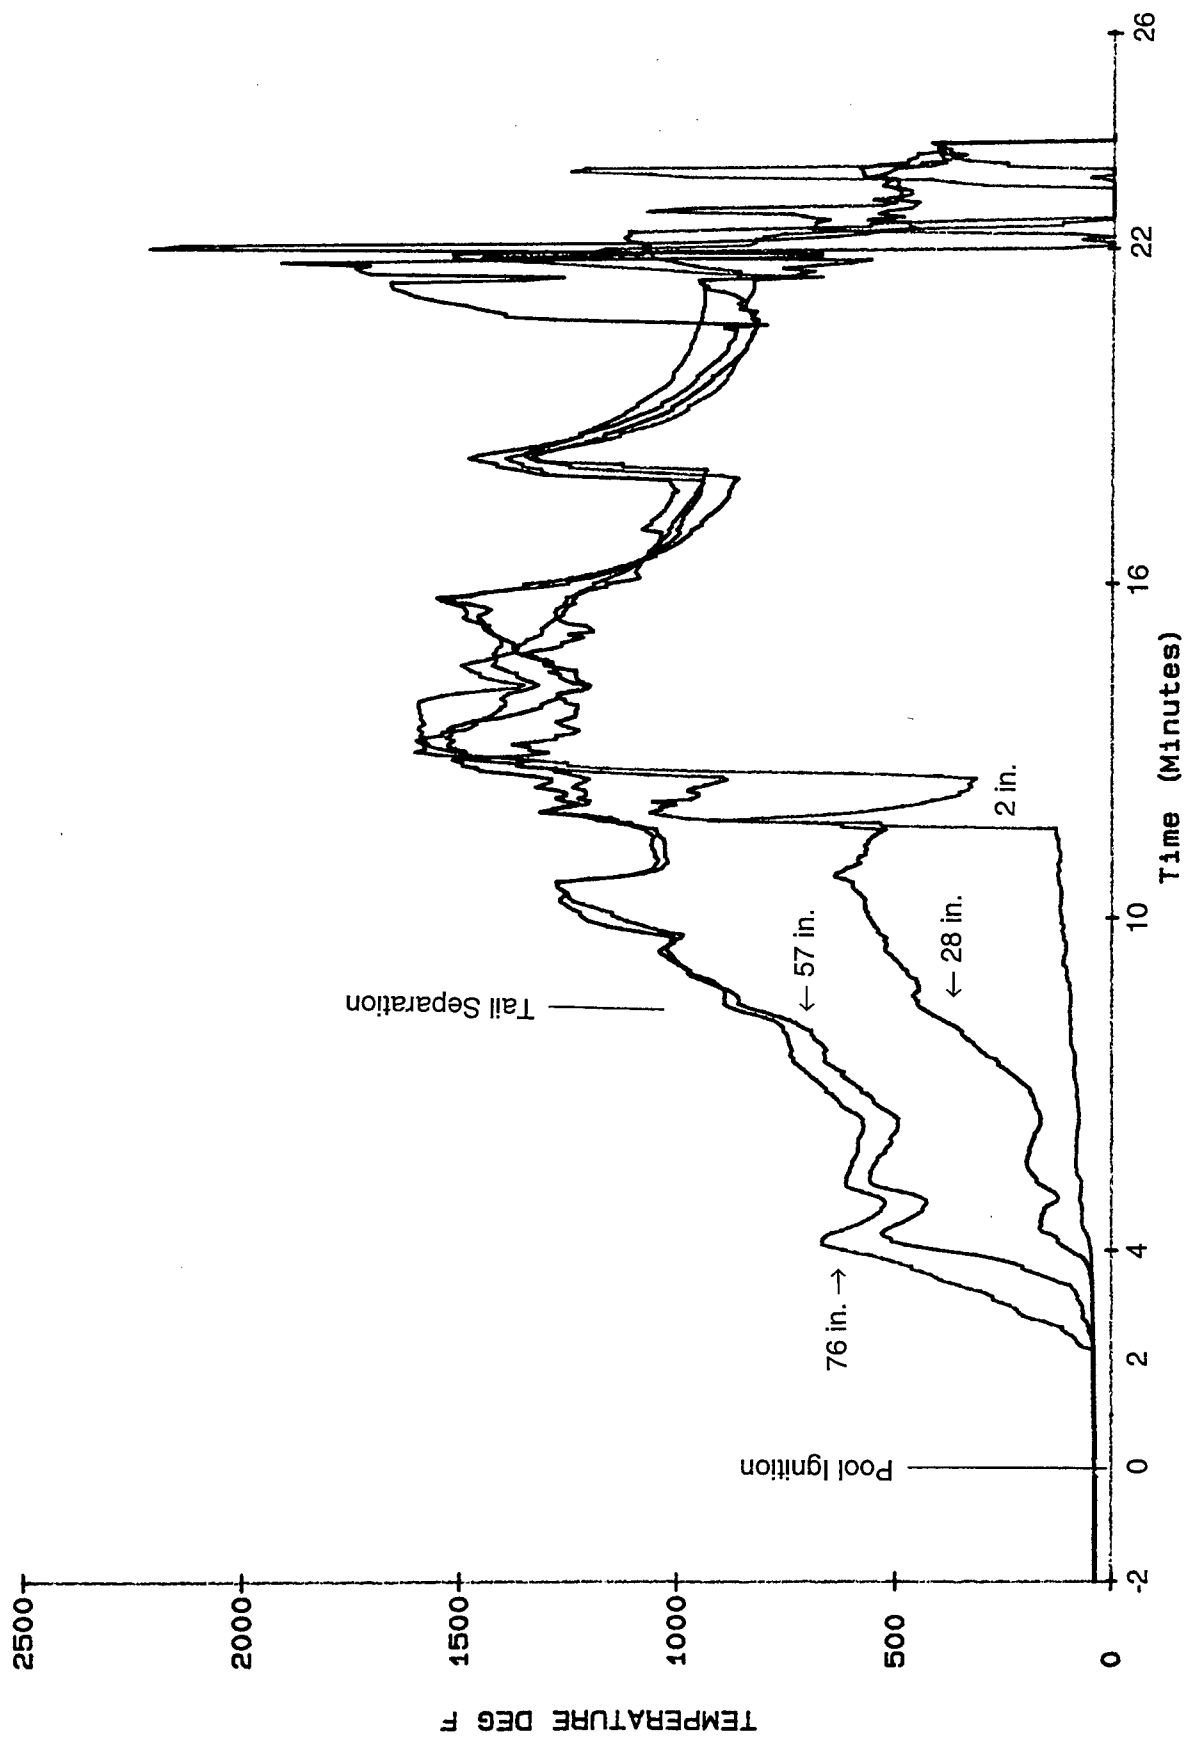
FIGURE B-18. THERMOCOUPLE TREE 3 AT STATION 669

The thermocouple tree at station 669 measured a far less severe rise in the air temperature due to its distance from the initial burnthrough and resultant interior fire (figure B-18).

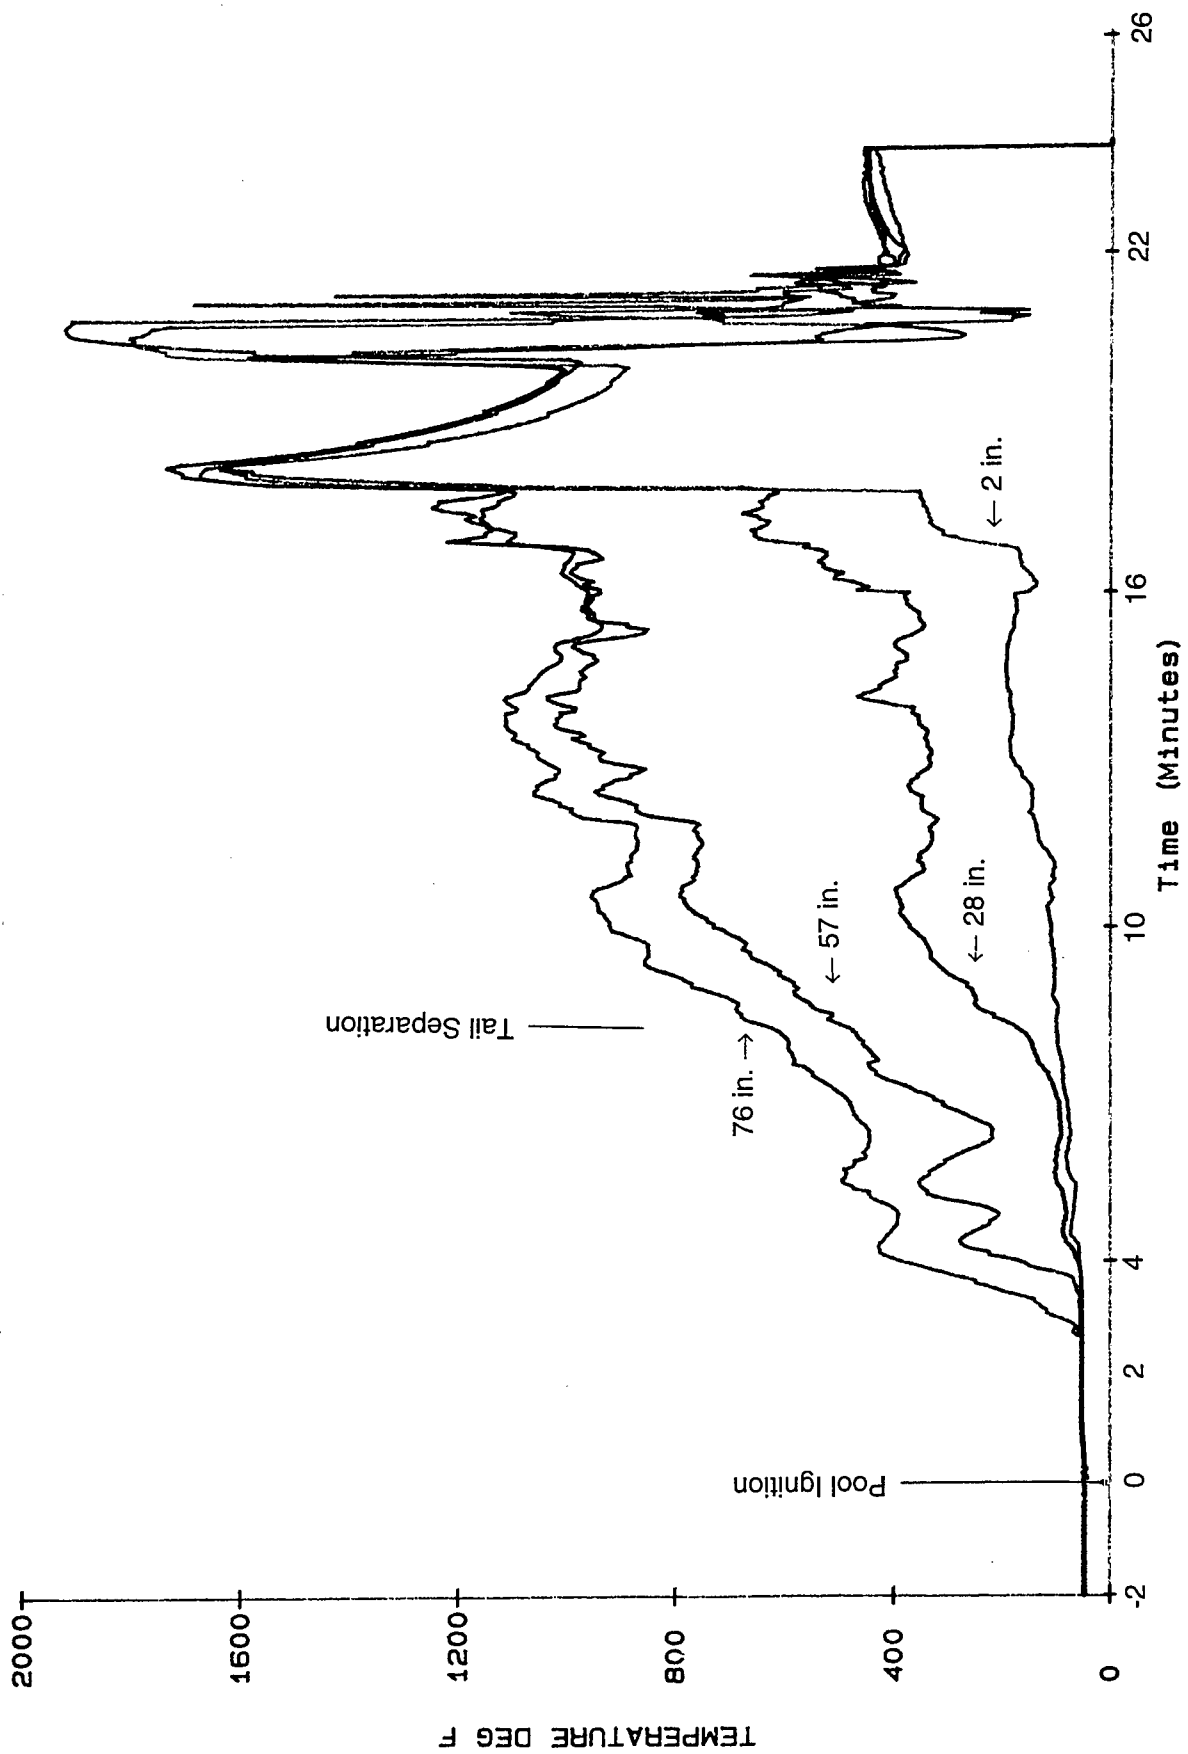
FIGURE B-19. THERMOCOUPLE TREE 4 AT STATION 498

The thermocouple tree located at station 498 measured the temperature profile in the first-class cabin (figure B-19). This area was the farthest away from the initial burnthrough.
